Service Bulletin

Drifting resistance on "H" circuit.

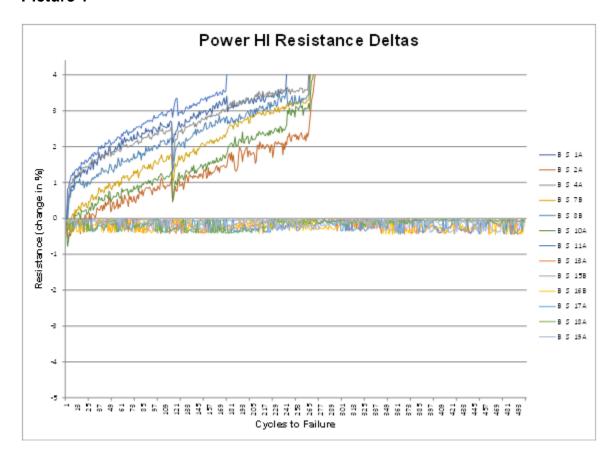
PWBi has become aware of an issue with certain test results showing a slowly increasing resistance on the H circuit (see Picture 1 below). This can lead to the system rejecting the H circuit and in some cases the S circuit. This issue is caused by a copper diffusion into a tin-lead surface finish at high temperatures over an extended period.

At higher temperatures and over an extended period the copper of the H circuit will diffuse into the tin lead solder finish causing the cross-sectional area of the H circuit trace to be reduced. This will only affect coupons being tested with these parameters:

PWBi has made a software feature to compensate for the failure mode as depicted in Picture 1. The software feature will be listed in the Job settings tab as "Control Circuit Feedback" (see Picture 2 below). For coupons which meet the above criteria this setting should be set to "H". Software updates will be made available to all systems owners requiring this feature. If you have any questions or concerns, please contact Jason Furlong at 1-613-254-7004 or Jasonf@pwbcorp.com
